MAG Purifier Improves Lubrication on Turbo-centrifugal Compressor

Provides Optimal Performance

by
Gerald Munson
Mag Systems, Inc.

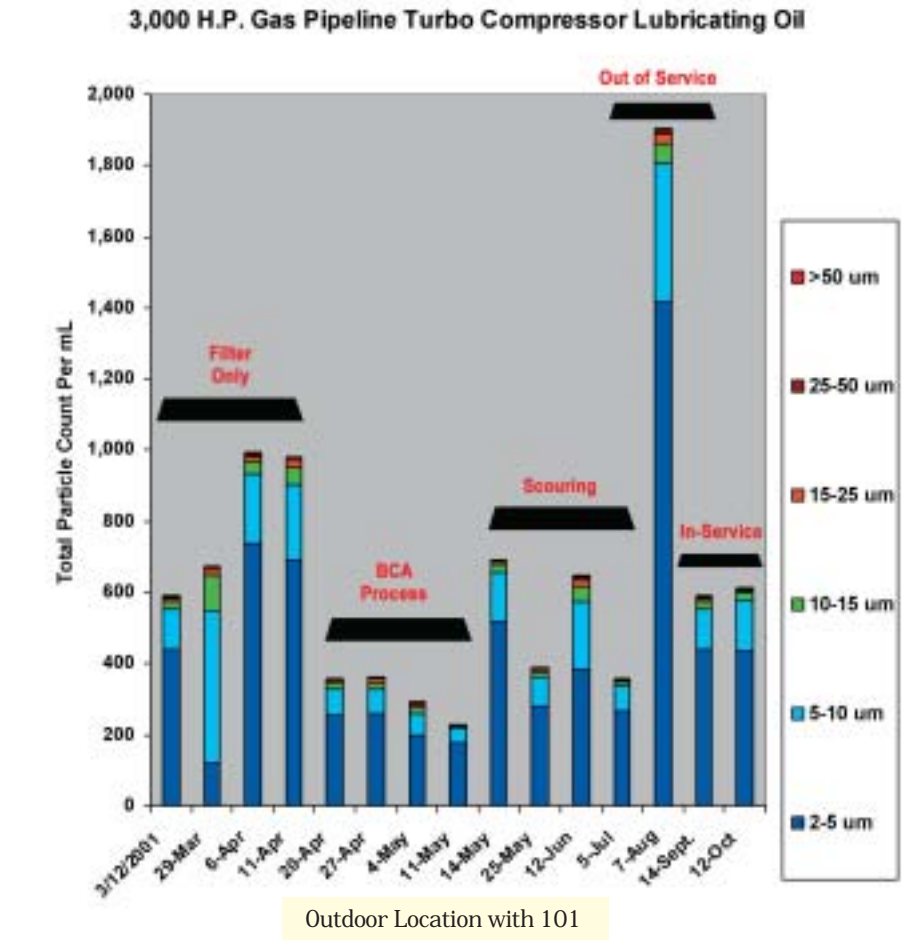
Fig 1 - Particle Counts

In mid April the electronic filters were energized, beginning the Balanced Charge Agglomeration process. Oil cleaning began immediately as can be seen on Figure 1.

After cleaning the oil for several weeks, the Balanced Charge process started to remove contaminants from the walls, lines, bearings and gears of the system. The system scouring began vigorously on 14 May 2001. The ISO code went up and down as the system removed material from the walls and the oil more rapidly. Variations in temperature influenced the up and down variability in the process during this period. (Material was removed at a faster rate at higher temperatures.)

The system was out of service from 01 August to 15 August. (See Figure 1 and Table 1.) The 07 August sample shows the scouring process was continuing in the absence of the ISOPur technology, as the balanced charge in the fluid continued to pull fine material from the system. Since the system was not removing the

accumulated particulate from the fluid during that time, it resulted in the spike shown on the graph. The September sample clearly shows that the oil and

system cleaning process had resumed at a normal level after the MAG system had resumed operation.

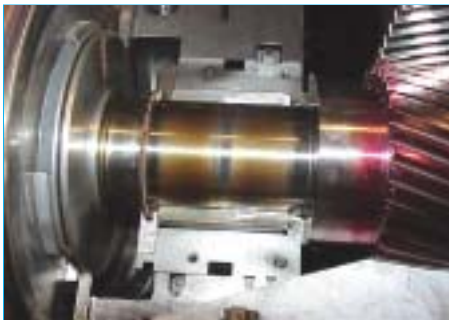
Shafts that were previously covered with brown varnish were completely bright. Journals that had segments of black varnish were either greatly reduced in varnish content or totally clean. Obviously, the Balanced Charge Agglomeration process has steadily removed contaminants from all of the internal surfaces of the equipment.

Fig 2 - Brown varnish on journals and shaft

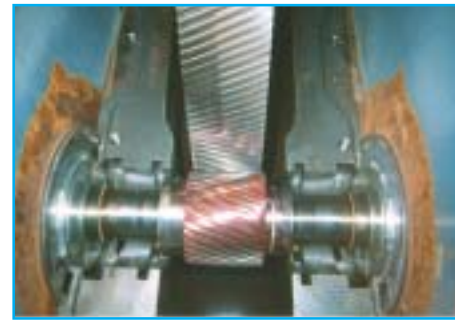
Fig 3 - Clean and bright

Shafts that were previously covered with brown varnish were completely bright

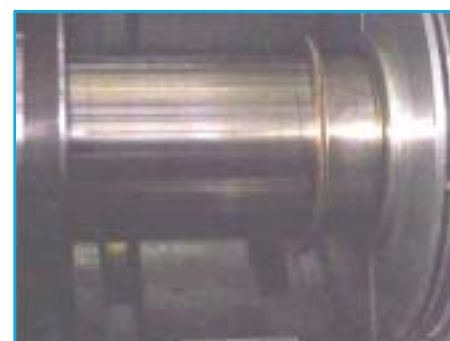
Fig 4 - Clean journal

Journals that had segments of black varnish were either greatly reduced in varnish content or totally clean

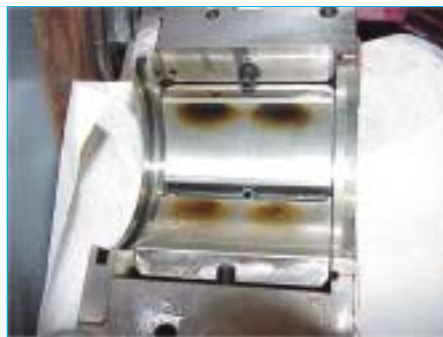
Fig 5 - Varnish on bearing pads

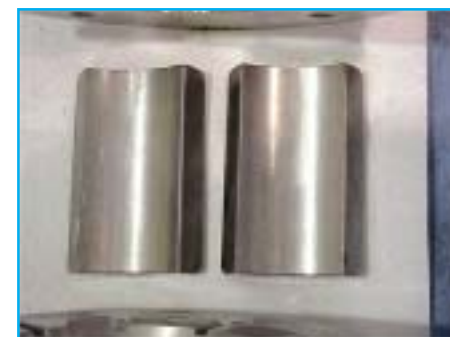
Fig 7 - Clean pads

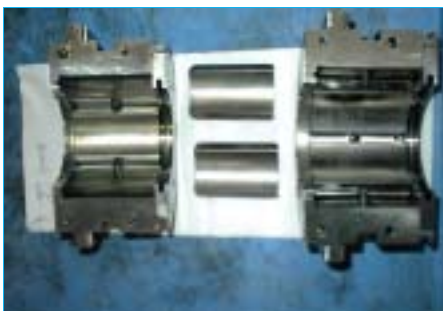
Fig 6- Clean pads

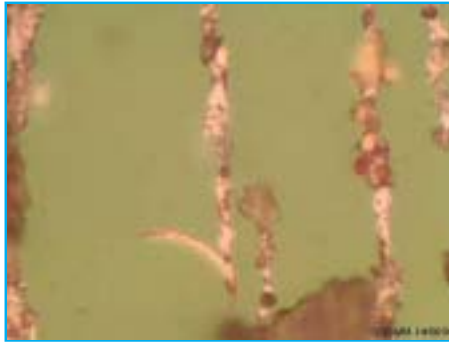
The residue from the Pre Filter Cartridge was determined to be 98% organic, 1% metallic and 1% other. This is very encouraging since the varnish was either organic or carbonaceous in nature, and the optical microscope was unable to distinguish between the two. The extremely low level of metallic components demonstrates that the existing level of oil filtration producing an ISO code of 15/11 is sufficient for this application. The total estimated weight of this debris was 3.2 grams demonstrating that less than 10 % of the capacity of the Pre-Filter cartridge was used during this period of operation.

The residue from the Collection Cartridge was determined to be ~78% Organic and ~16% metallic, with the balance being other.

This is consistent with the previous x-ray studies that revealed a low metallic nature of some of the heavy deposits in the system. The predominance of organic material is a further confirmation of the carbonaceous nature of the varnish deposits within the system. The total gravimetric weight in this filter was determined to be 0.25 Grams. This is

Fig 8 - Ferrogram
