Solution Found for

Hydraulic Servo Valve Sticking on Small Nuovo Pignone Gas Turbines by GE Service at YALE New Haven Power Plant

Abstract

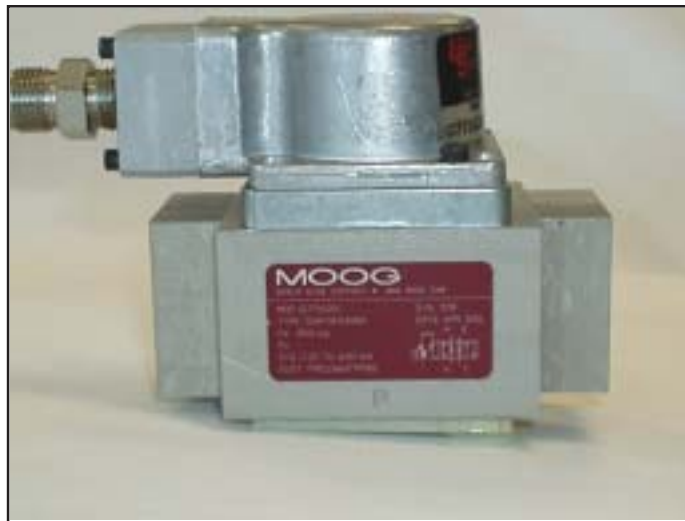
Each gas turbine contains a single lube oil sump (Mobil DTE Light) which is used to lubricate the Gas Turbine (28 PSI), lubricate the generator, (28 PSI) and supply hydraulic power (1000 PSI) to the Moog 770 series electro-hydraulic servo valves that control the gas turbine and fuel flow.

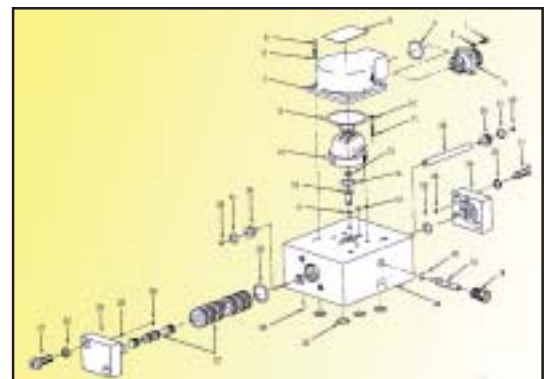
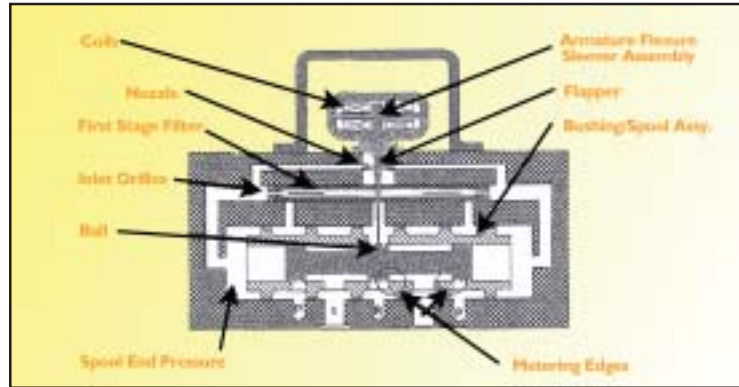
Moog Servo Detail

The Moog valve is essentially an electric current to fluid flow transducer. The

force of a small solenoid is amplified by hydraulic pressure to provide precise control. The valve comprises a tremendous number of parts, most of which fit together with only a few microns clearance. The valve spool, null bushing and bore must be perfectly aligned matched sets with no interference to provide precision translation of milliamps of current into smooth proportional valve motion. Any interference restriction or imbalance will insert a discontinuity between the control signal and output destroying precise regulation. Flow is controlled from 1.0 GPM to Zero and zero to 1.0 GPM, all at 1200 PSI.

- the inlet orifice
- the filter
- the nozzles
- the flapper
- the ball
- the bushing
- the spool
- the metering edges

Any contamination at these locations is an immediate malfunction.

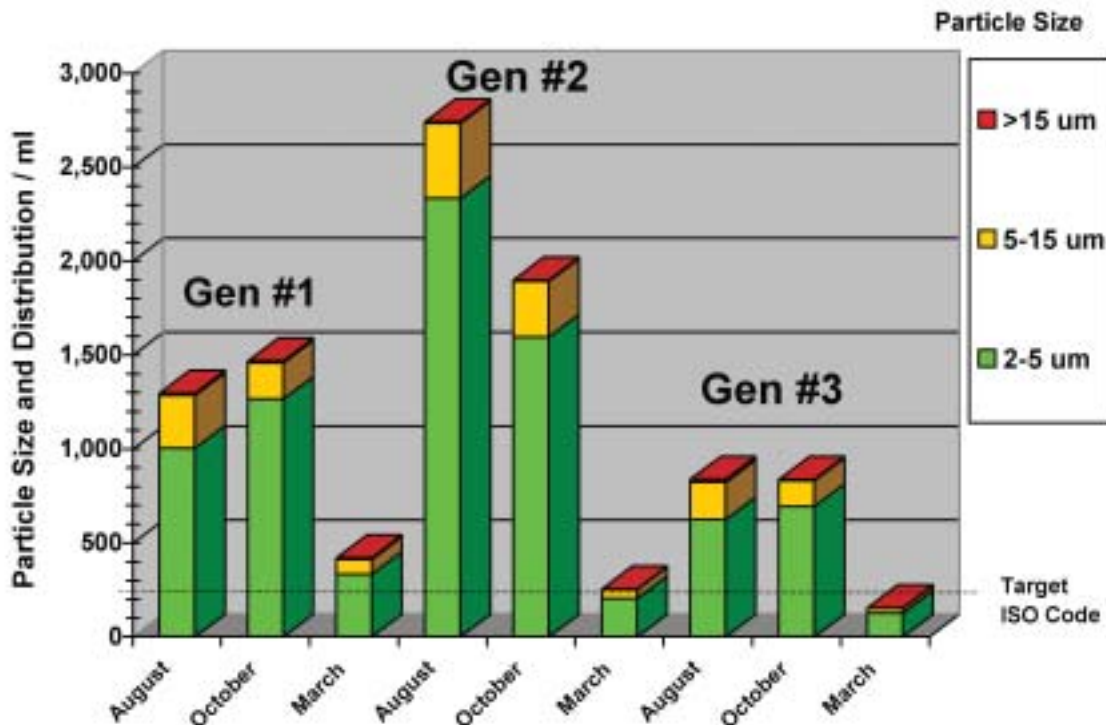
Gas Turbine Lube Oil Particle Count History

Installation of the ISOPur model 50 fluid purification systems on the three Nuovo Pignone PGT5 gas turbines produced an immediate and continuing positive effect not only on the MOOG Servo valves but also on the entire turbine Lube Oil system. The data and graph that

follows show dramatic reduction in large and small particulate contamination in the oil. In addition, the physical condition of the fluid continues to improve as indicated by

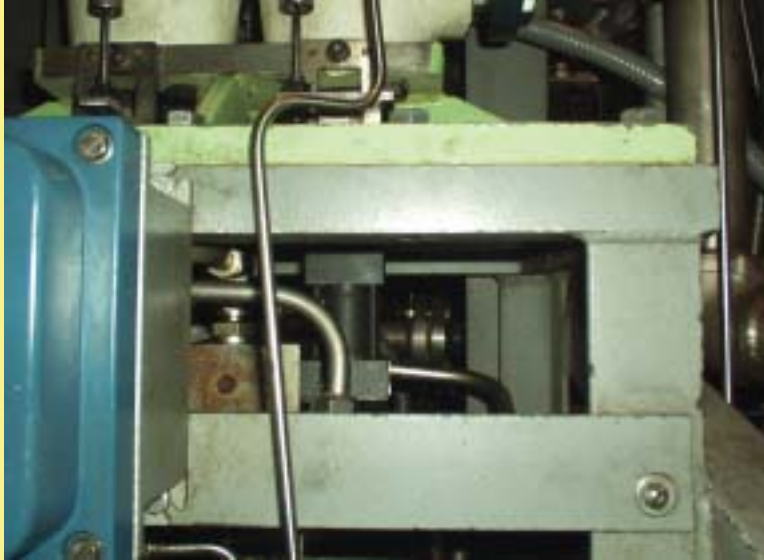
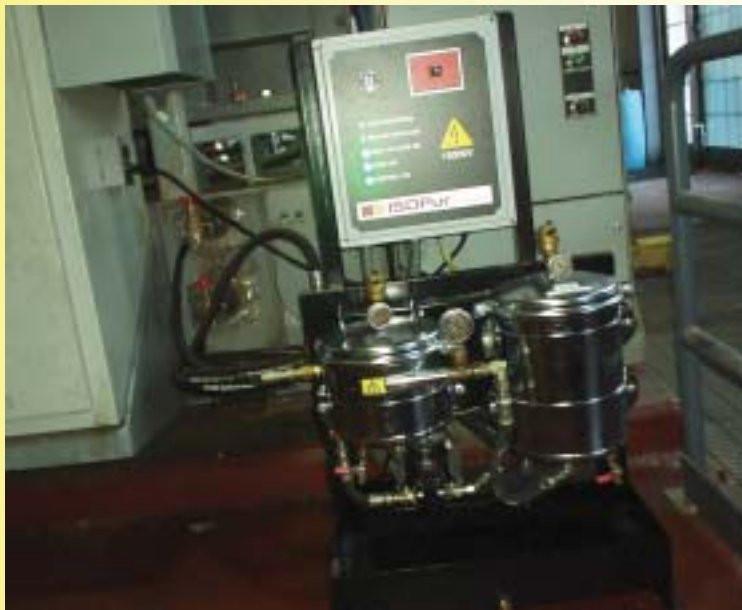
a return to normalization of all of the relevant oil parameters (by FTIR). Reduction of the water content to impressively low levels on an ongoing basis will ensure

*Hydraulic Leak detected into Lube oil sump / Correct leak & bleed & feed to correct
