MAG Purifier Improves Lubrication on Turbo-centrifugal Compressor

Provides Optimal Performance

by
Gerald Munson
Mag Systems, Inc.

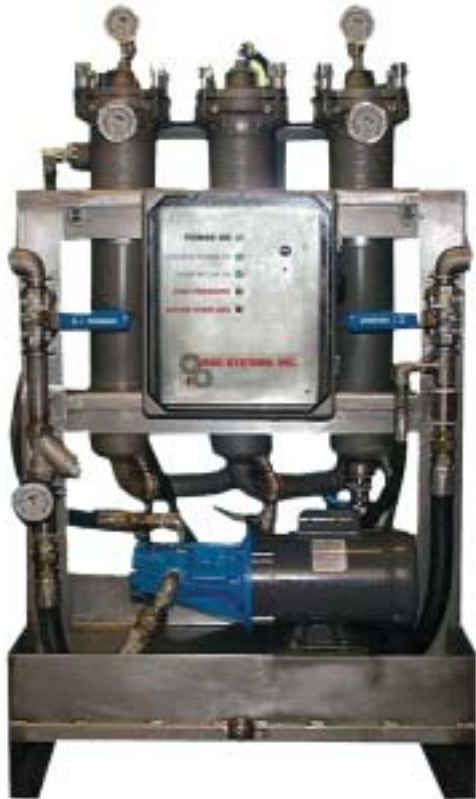
Three thousand horsepower turbo-centrifugal fans rotate at extremely high speeds to maintain pressures in pipelines and other critical applications.
