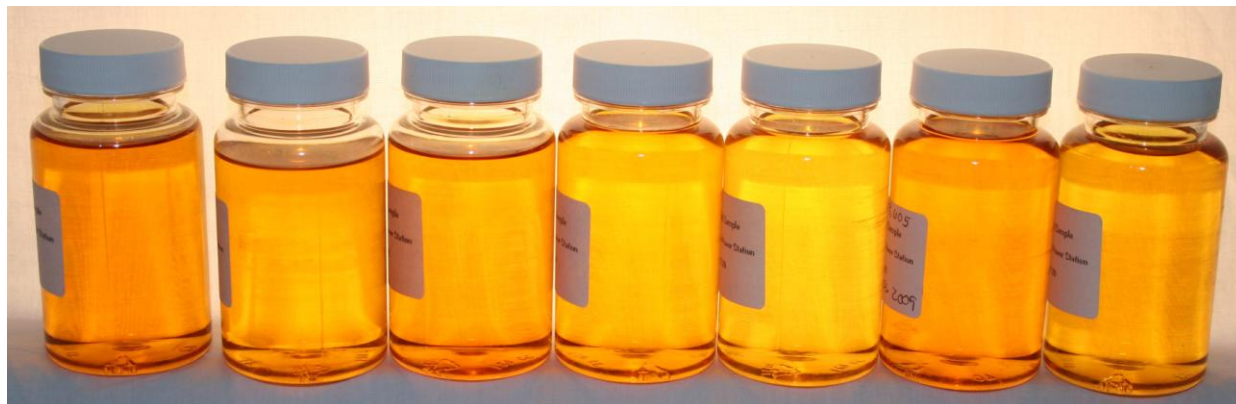
Now, nearly eight years since the plant went into operation, the original oil installed at commissioning has over 35,000 operating hours and is still in use. The varnish potential numbers on the latest sample, in July 2009, indicate the oil is as clean as, or cleaner than new oil. New oil VPI, on a scale of 0 to 100, has a rating of 1 to 3. The average of the seven samples from their turbine lube oil is 10 with two samples at 3 on the VPI scale.

Within a few weeks, the benefits of installing the new systems were beginning to show. All 7 GE 7FA turbines experienced a rapid drop in VPI, Varnish Potential Index, and servo valve trips stopped. At the first inspection of the oil sump, the plant maintenance staff was surprised to find that varnish and sludge deposits were disappearing and the tank did not need cleaning.
